PRODUCT INFORMATION BULLETIN

Date: September 17, 2013
 Number: 6274
 Division: Genie®
 Product Family: Residential Openers
 Product Series: Accessories
 To: All Genie Professional Line Wholesalers, Dealers and Installers
 Re: Integrated Reinforcement of the S3 Circuit in Series II Wall Consoles

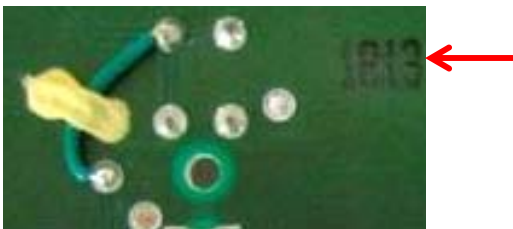
Wall Console Circuit Boards **BEFORE** the change

In an effort to enhance our current wall console design, we added *integrated* reinforcement to the wall console circuit board in wall consoles manufactured after May 2013. This integrated reinforcement in the wall console circuit board eliminates the use of reinforcement wiring (e.g. “jumper wire” – green wire shown below on the left).

- ▶ Jumper Wire is visible (green wire)
- ▶ Date Code is 2313 or before (see red arrow)

➔ To read the date code format on the back of the Wall Console: WWYY (WW-Week of Year, YY – Year).

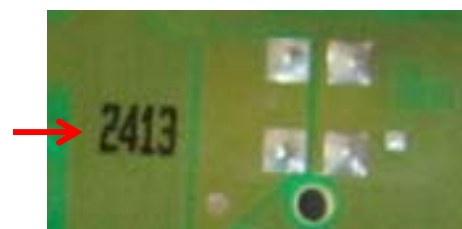
Wall Console Circuit Boards **AFTER** the change

Please note, you will no longer be able to visibly see any additional wiring on wall console circuit boards that have been updated with this integrated reinforcement.

- ▶ NO Jumper Wire is visible
- ▶ Date Code is 2413 or after (see red arrow)

Wall consoles with the updated circuit boards can be found in affected model opener cartons with the first five serial numbers of 13253. To read the serial number format of one of these opener cartons: YYDDD (YY – Year, DDD – Day of Year), Example: 13-2013, 253 – 253rd Day
